PRELIMINARY INVESTIGATION OF EFFECT OF HYDROGEN ON
STRESS-RUPTURE AND FATIGUE PROPERTIES OF AN
IRON-, A NICKEL-, AND A COBALT-BASE ALLOY

By Stanley J. Klima, Alfred J. Nachtigall,
and Charles A. Hoffman

December 1962

TECHNICAL NOTE D-1458

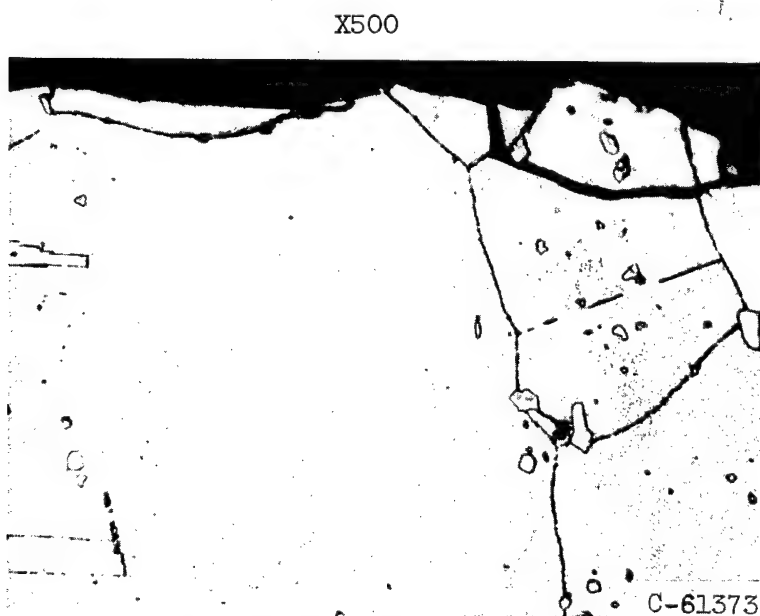
(b) Inconel 700; internal surface exposed to hydrogen; life, 89.0×10^6 cycles (750.4 hr).

Figure 5. - Continued. Transgranular fractures typical of failures encountered in fatigue tests with both air and hydrogen.

Photomicrographs of typical failures encountered in both the hydrogen and air fatigue tests for each of the alloys investigated are shown in figure 5. Similarly, photomicrographs of typical failures encountered in stress-rupture tests are shown in figure 6. As shown in these figures, the fatigue-test failures were generally transgranular, and the stress-rupture-test failures were generally intergranular in nature, regardless of the alloy or the gas passed through the specimen. It is evident from figure 6 that many small cracks generally occurred in the area immediately adjacent to the fracture surface in the stress-rupture specimens. Except for S-816 (fig. 5(c)), only a few such small cracks and frequently none at all occurred in the failure area of the fatigue specimens. Macroscopic and microscopic studies of hydrogen-tested fatigue and stress-rupture specimens indicated that these small cracks occurred on both the internal (hydrogen side) and external (air side) surfaces. Normally, they were not concentrated primarily on one surface in preference to the other.

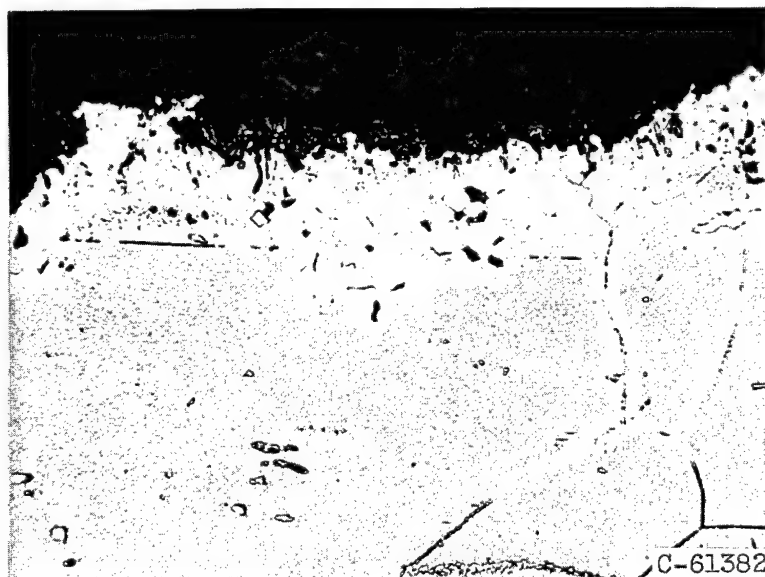
(b) Inconel 700; fatigue test; life, 83.4×10^6 cycles (705.5 hr).

Figure 9. - Continued. Typical specimens showing both internal and external surfaces in region of failure. Internal surface exposed to dried air; external surface exposed to relatively humid air. X500.

Figure 9 shows typical microstructures along both the internal and the external surfaces of specimens of each alloy after air tests in the areas near the specific points of failure. Figure 10 presents similar

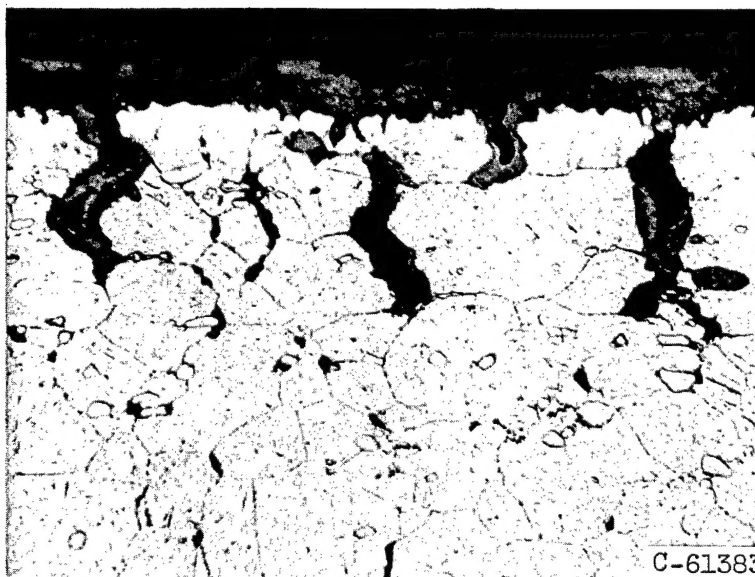
(c) S-816; stress-rupture test; life, 232.8 hours.

Figure 9. - Concluded. Typical specimens showing both internal and external surfaces in region of failure. Internal surface exposed to dried air; external surface exposed to relatively humid air. X500.

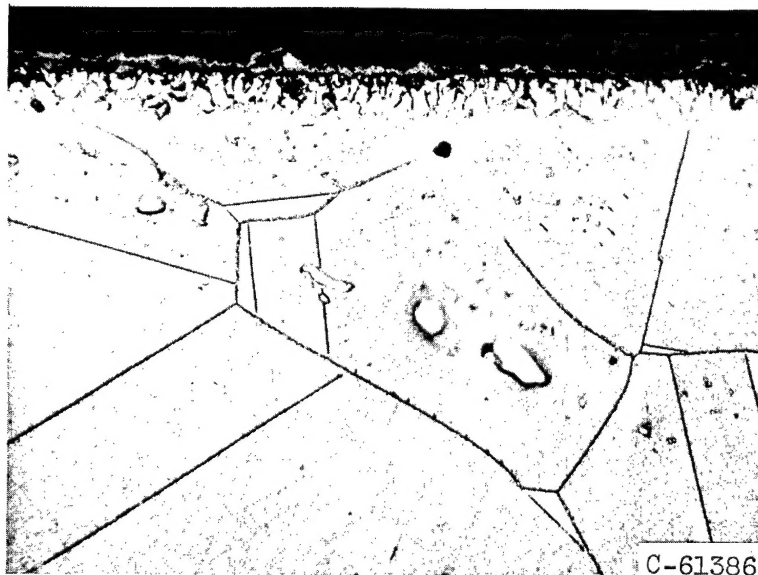
(b) Inconel 700; fatigue test; life, 47.4×10^6 cycles (401.6 hr).

Figure 10. - Continued. Typical specimens showing both internal and external surfaces in area some distance from region of failure. Internal surface exposed to dried air; external surface exposed to relatively humid air. X500.

photomicrographs of additional specimens of each alloy, which show regions away from the failure area. It is apparent from these figures that, in general, a considerably thicker scale was formed on the external surface exposed to relatively humid air rather than on the internal specimen surface exposed to dried air. This scale extended through both the cracked and uncracked areas. Microscopic examination indicated that considerable oxidation occurred in the cracks that formed near the point of failure of air-tested specimens in all the materials investigated. Oxidation occurred in the cracks that extended from the internal surface as well as those that extended from the external surface. This was most apparent in stress-rupture tested specimens and is best illustrated in figure 9(c). No oxidation occurred in the cracks that extended from the internal surfaces of specimens exposed to hydrogen.]
